# City of Iola, KS

## WASTEWATER COLLECTION SYSTEM REVIEW AND ASSESSMENT

DESIGN MEMORANDUM

PROJECT NO. 08A54-003-3704  
July 2011

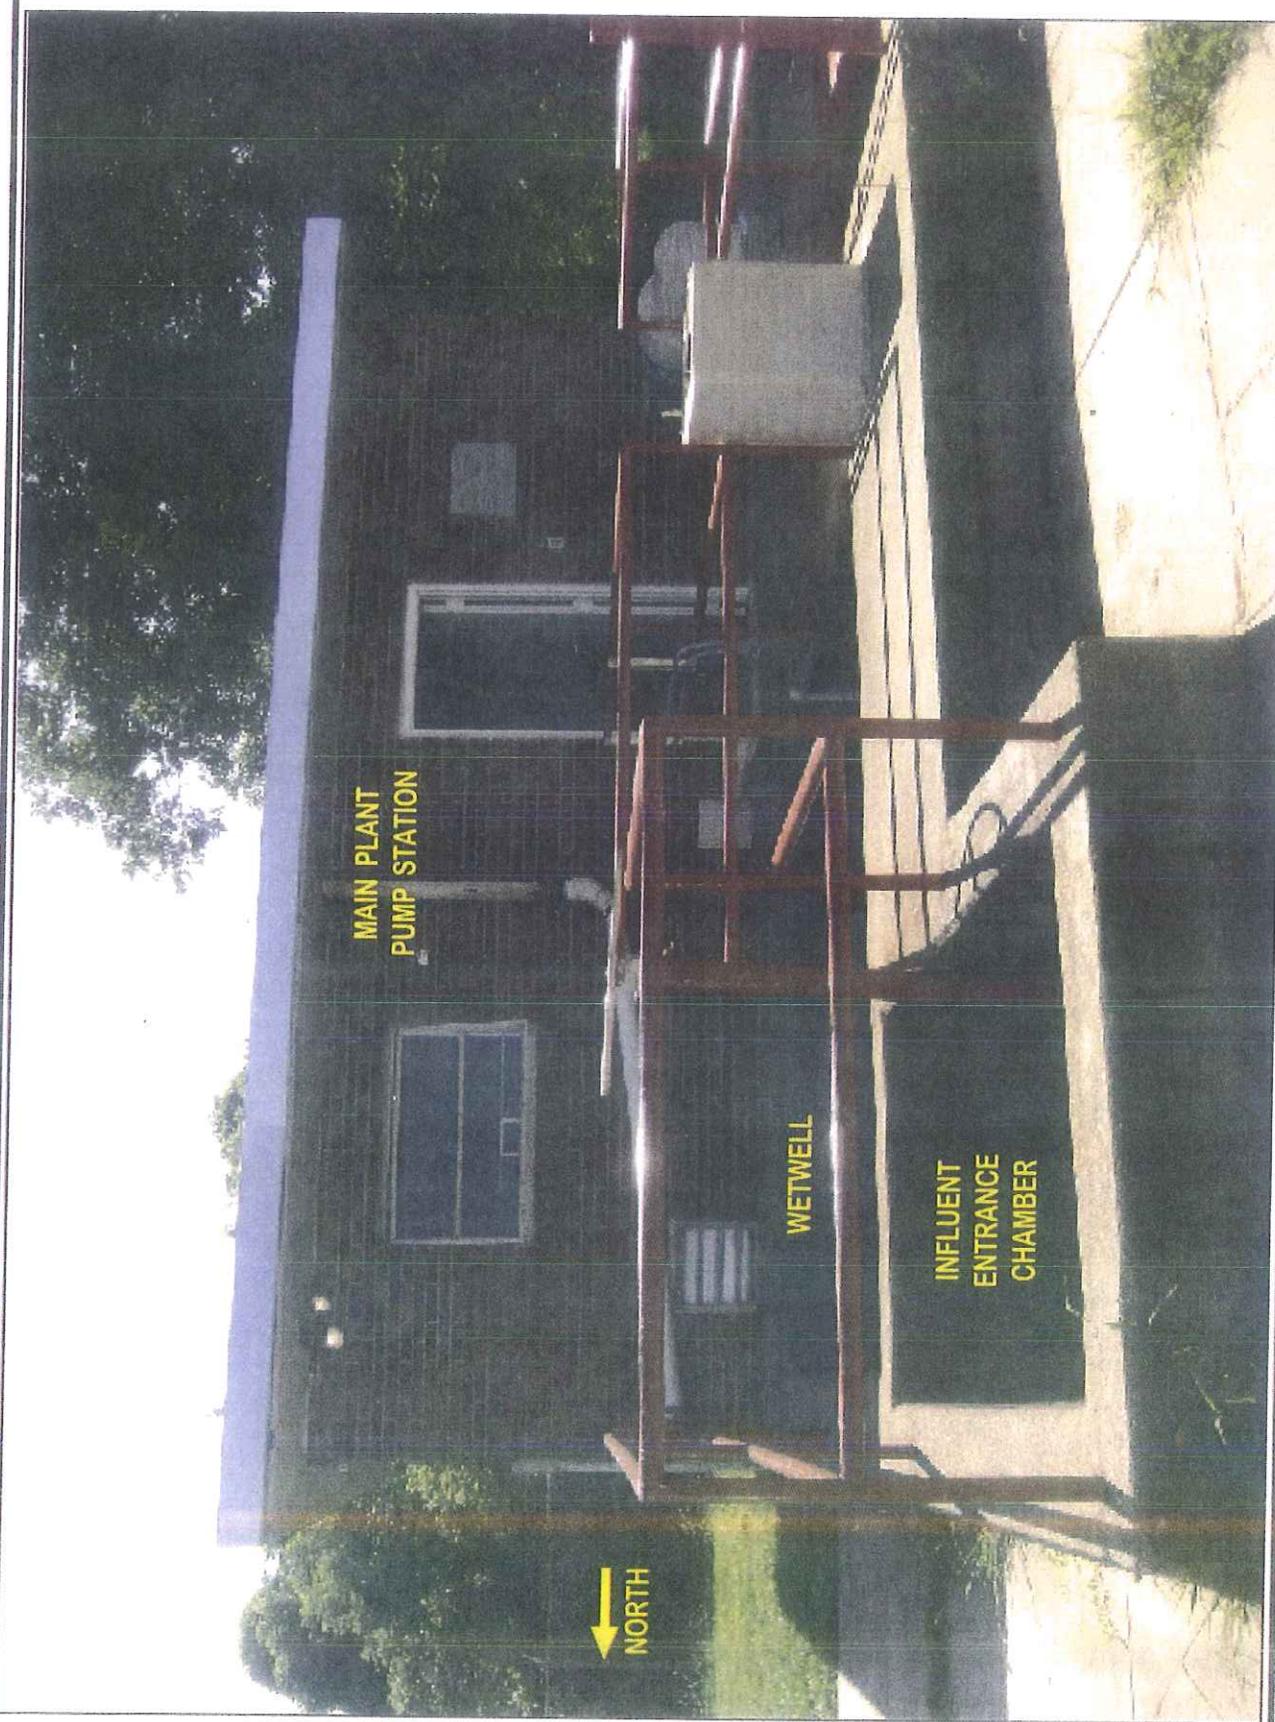
PHOTO 1

**2007 Flood** - The Main Plant PS was submerged in 2007 with the maximum water level reaching an elevation of nearly 3 feet above the floor of the electrical and control building located on top of the station. The pump station was restored to service after the flood waters receded. The improvements to replace the pumps, valves, and controls were completed along with lagoon improvements in 2008.

**Existing Conditions** - The structure for this pump station is cast-in-place concrete and is in very good condition. The building housing the electrical and control panels is brick with a concrete roof and is also in good condition. At the time the design of the upgrade to the station was being undertaken, it was determined by the City that changing of the pumping capacity was not required. The Auxiliary PS was fully functional at that time and was available to pump peak wet weather flows in conjunction with the Main Plant PS.

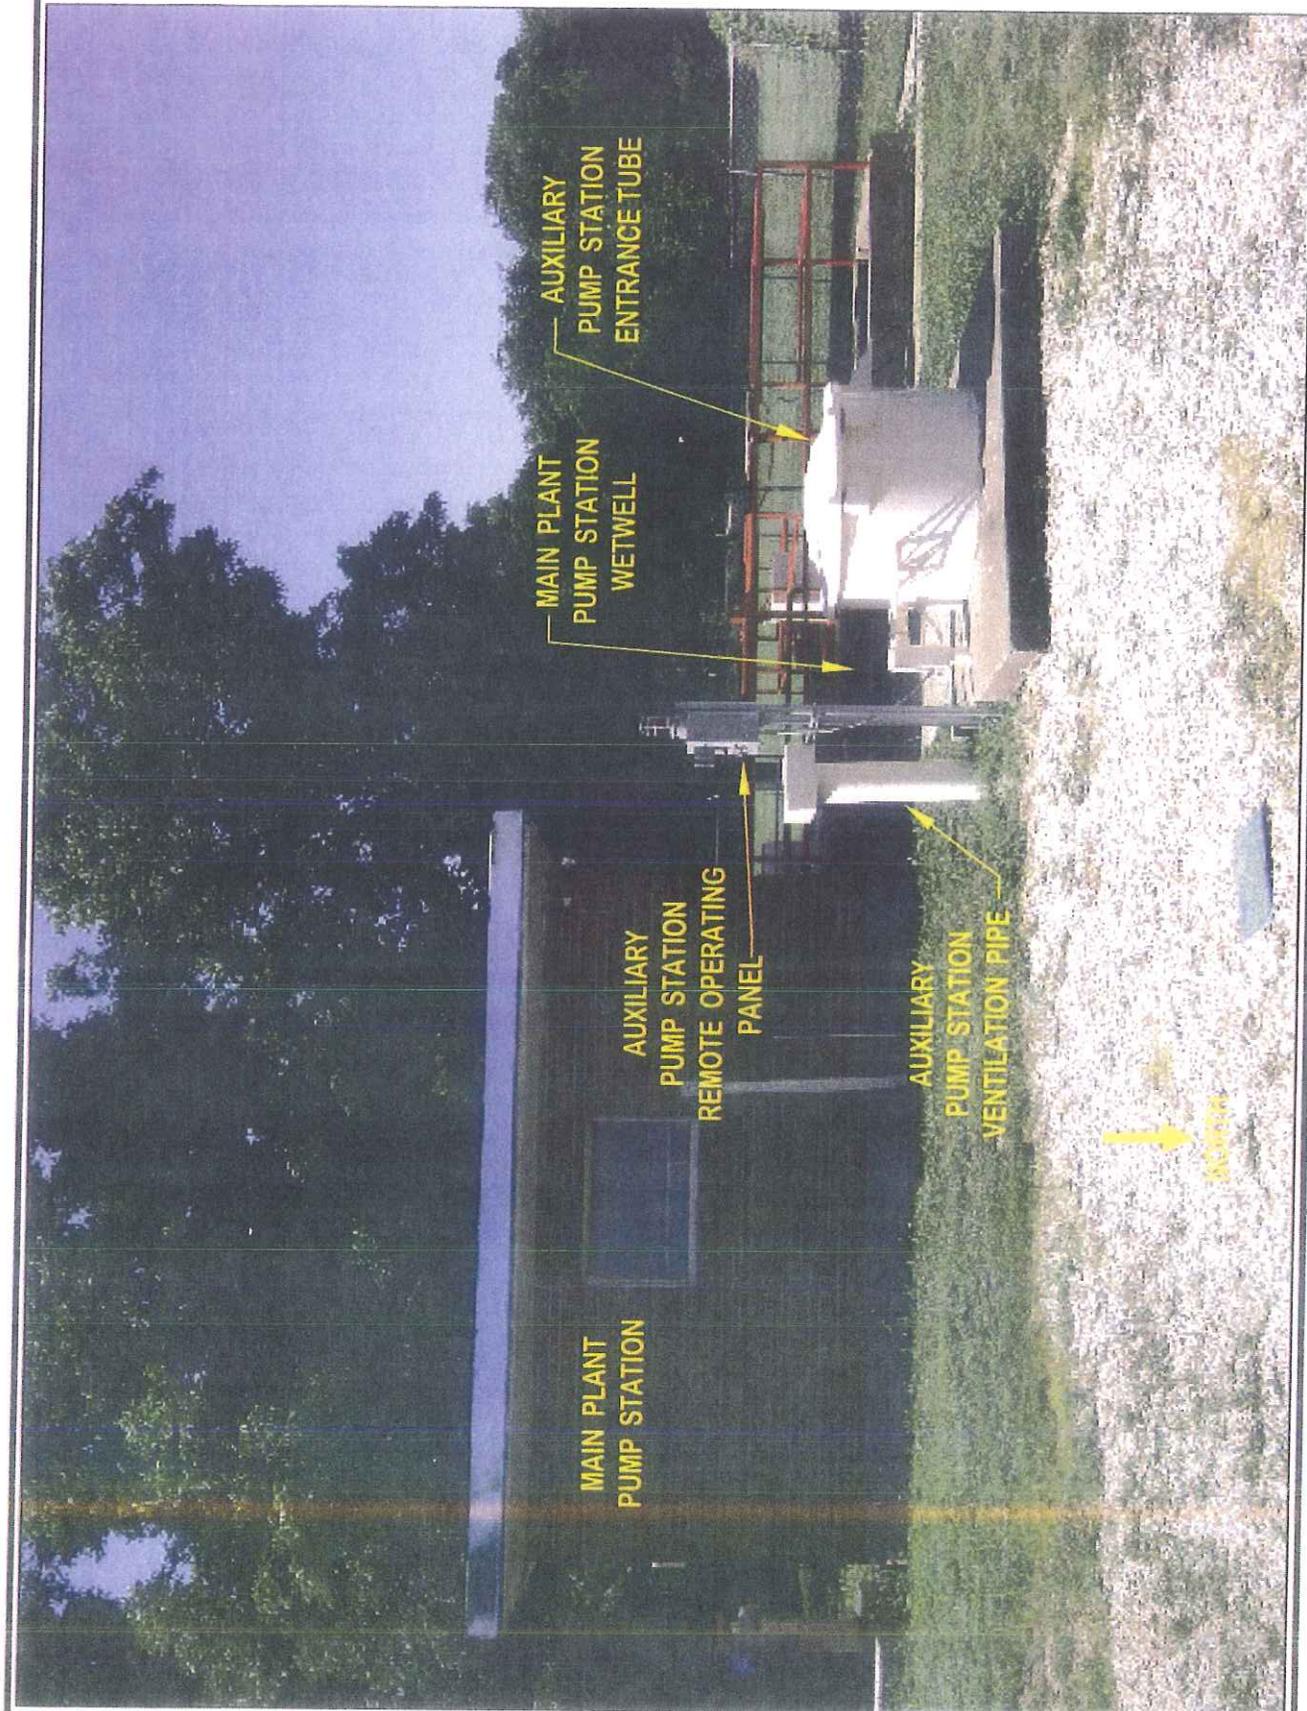
PHOTO 2  
MAIN PLANT AND AUXILIARY PUMP STATION  
COLLECTION SYSTEM ASSESSMENT

**2007 Flood** - The below ground chamber of this pump station filled with flood water in 2007. The water was pumped from the station and the motors and controls dried out. The pump station was returned to service. In 2008, a leak in the water line serving the station filled the below-ground chamber, requiring actions similar to what was needed following the 2007 flood to bring the station back into service. The station is considered to be highly unreliable by the operating staff. A manual on/off switch and alarm light were installed at ground-level near the entrance tube to reduce the need for entering the below-ground chamber.

**Existing Conditions** – The pump station consists of a pre-manufactured steel chamber with a steel access tube. The station is about 20’ deep and there is no a manlift provided. There has been some damage to the steel chamber and access tube from corrosion that must be addressed if the station were to remain in service. The electrical power source for the Auxiliary PS is shared with the Main Plant PS. The susceptibility of this station to be damaged by flooding and the safety concerns with entering a deep steel chamber containing electrical equipment are reasons why this station is being evaluated for removal from service. There is no standby generator at the site.

The reliability of operation is considered low by City staff. They have concerns about safety because this is a below-ground steel chamber where persons entering and leaving must climb a 20’ long ladder. The station is considered as a “confined space entry.” The station has also been full of water twice, with damage to the pump motors and electrical gear.

**Identified Improvement Needs** - As mentioned under the Main Plant PS discussion, above, a separate letter report has been prepared to review replacement of the Auxiliary PS. See Appendix D for a copy of the letter report.

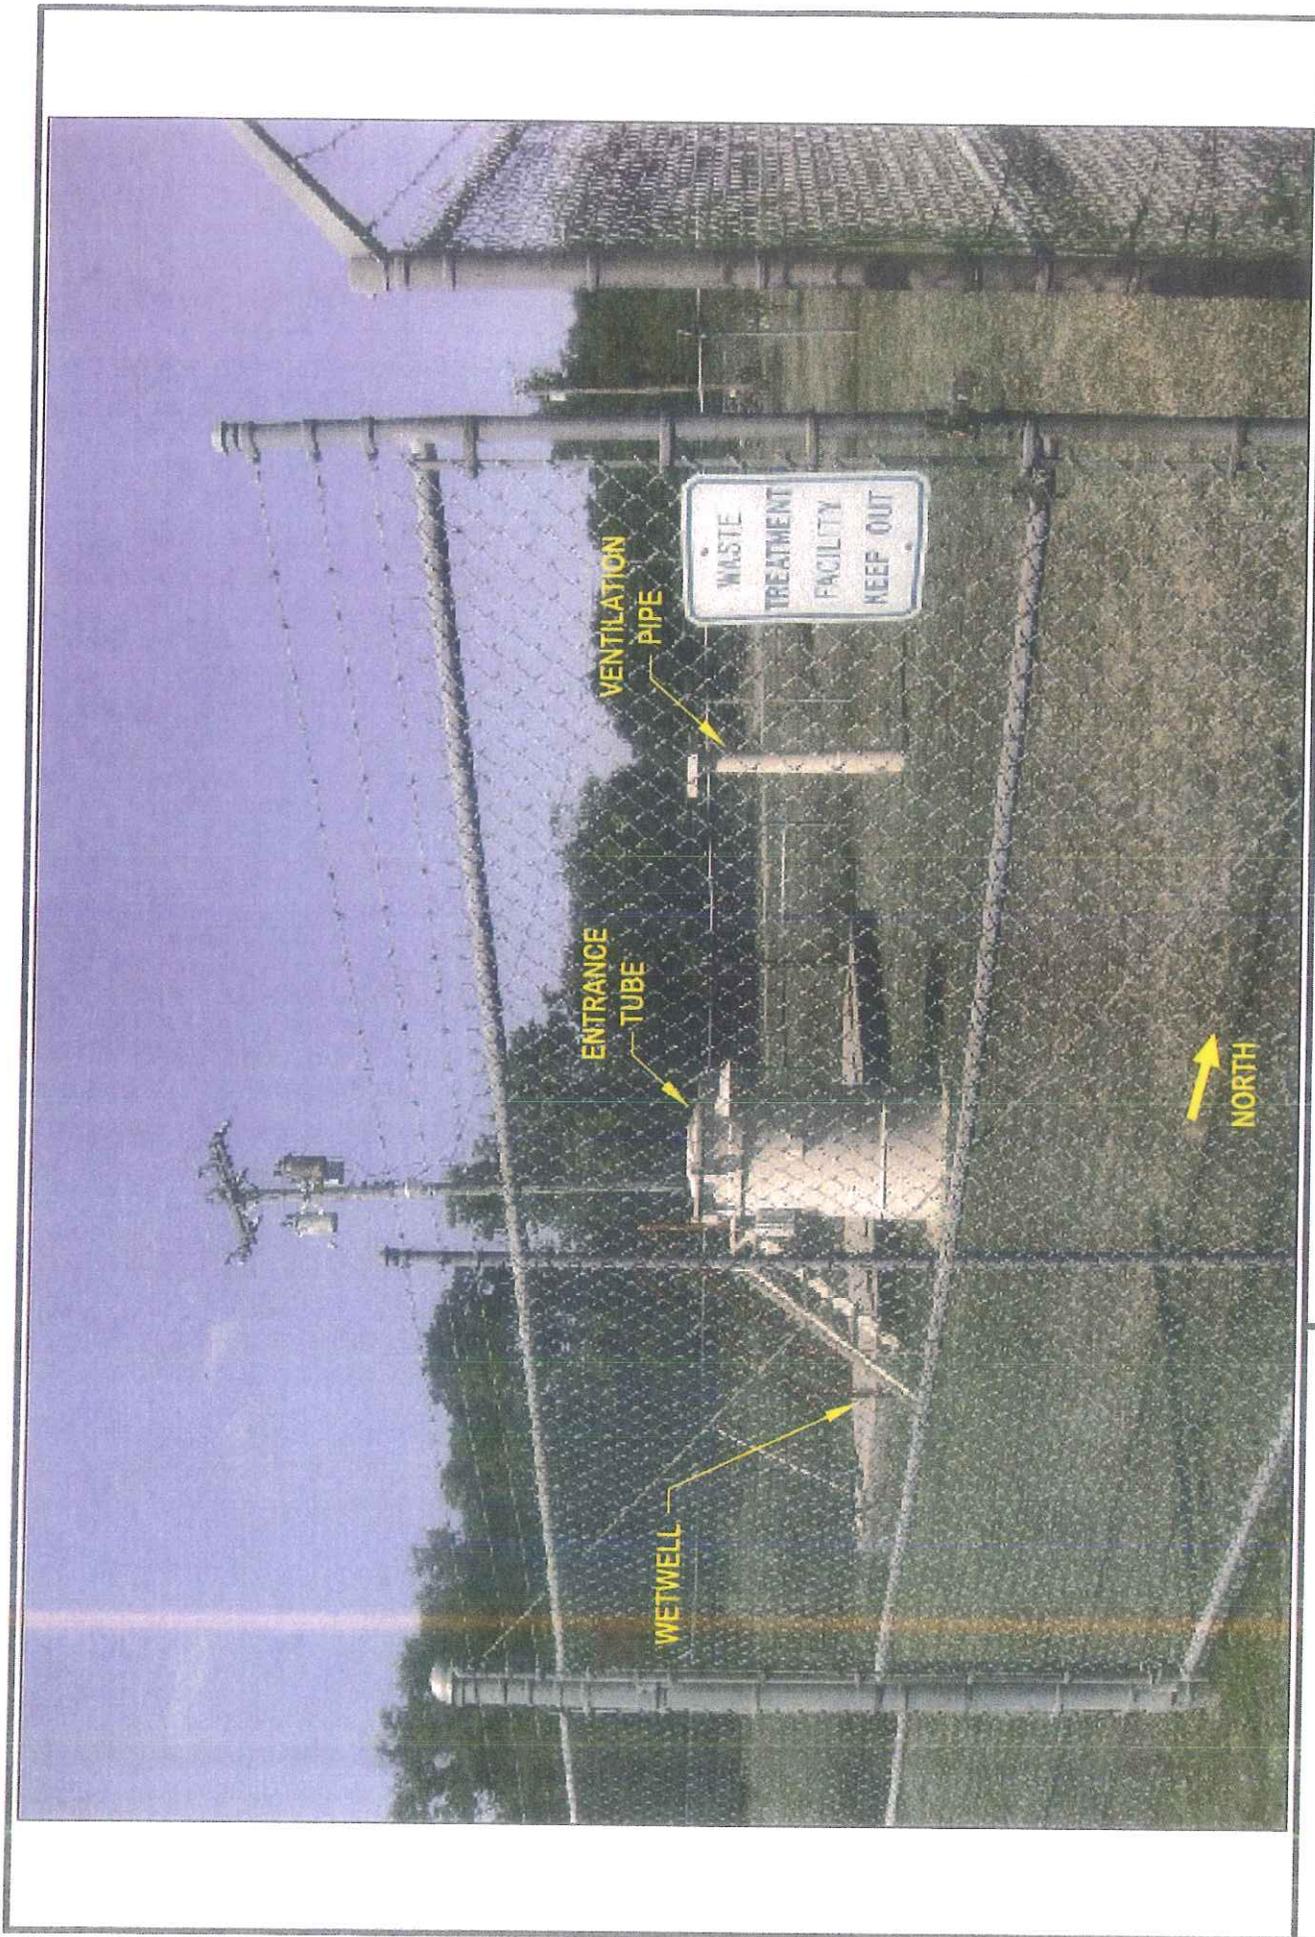
PHOTO 3  
OHIO PUMP STATION  
COLLECTION SYSTEM ASSESSMENT

**2007 Flood** – The station was not damaged by high waters in 2007. However, the flood waters did overtop the wetwell.

**Existing Conditions** – The Ohio PS is a below-ground steel chamber housing the pumps and electrical controls. The steel structure is in poor condition due to deterioration from corrosion. The electrical gear and level controls are obsolete and can no longer be supported with replacement parts. The pumps take suction from a cast-in-place concrete wetwell adjacent to the pump station. Due to the size of the wetwell compared to the current influent flow rate and due to the length of the interceptor conveying wastewater flow from the northeast corner of Iola, the contents of the wetwell are septic and create corrosive gases. As a result, the wetwell concrete is deteriorated. The manholes on the interceptor receiving the flow from the pump station have also been subjected to significant corrosion. See Section 6 of this Design Memorandum for specific recommendations for manhole rehabilitation.

**Identified Improvement Needs** – The operational problems mentioned are with station capacity being far greater than presently needed, the electrical and control components are obsolete, the steel structure is significantly deteriorated, and the station configuration requires entry into a confined space. Due to these significant operational, structural, age, and safety concerns, the station should be replaced. Protection of the wetwell structure by coating the interior surfaces with a high-build epoxy or polyurethane would protect the structure from further deterioration from corrosion if it can be re-used with a new pump station.

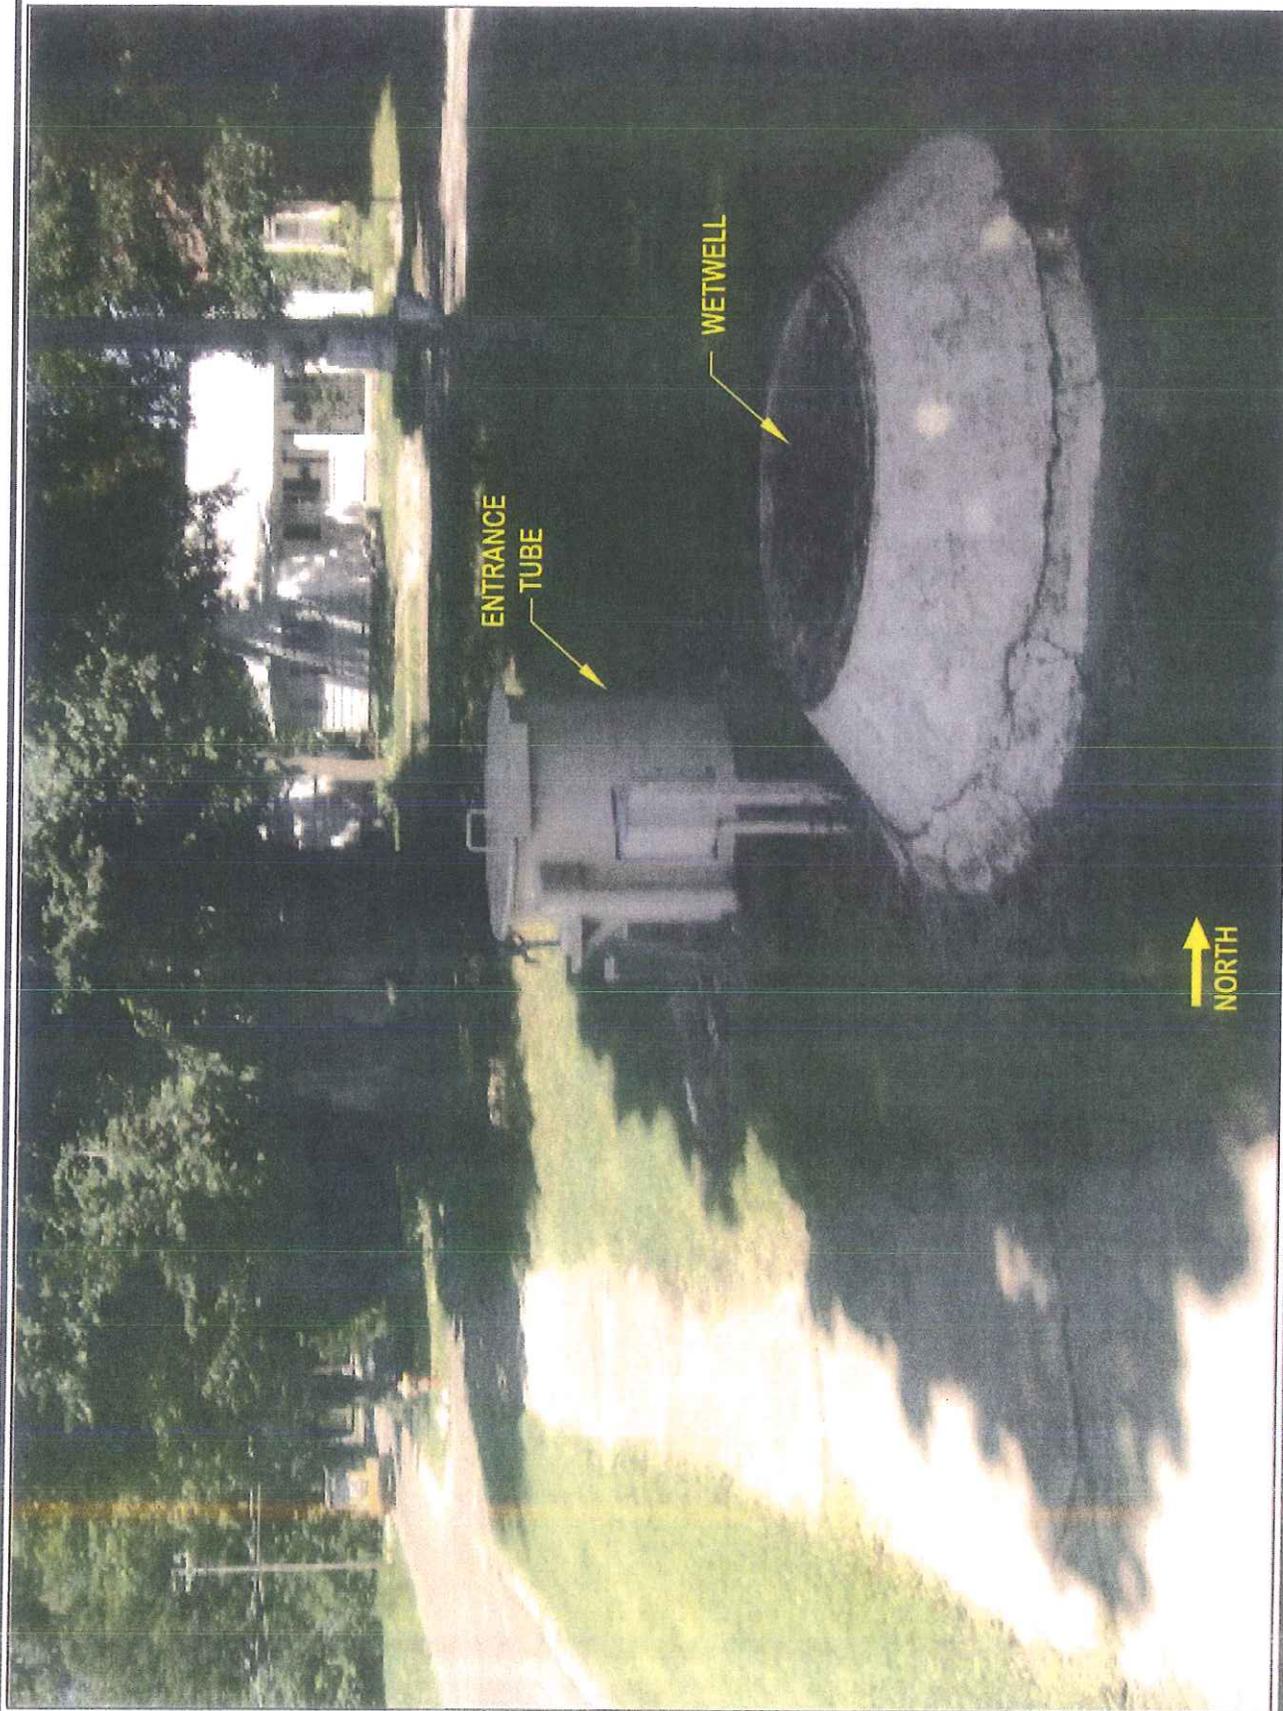
PHOTO 5  
VINE STREET PUMP STATION  
COLLECTION SYSTEM ASSESSMENT

**2007 Flood** – This station was reported to have not been damaged by the 2007 flood; however, the tributary sewers and the sewer receiving the pumped flow were all surcharged and overflowing.

**Existing Conditions** – The pump station below-ground steel chamber is in relatively good condition. The wetwell appears to have been coated with a cementitious material over the brick some time in the past, and that material is now coming loose in chunks. Level control is provided by six float switch suspended in the wetwell.

**Identified Improvement Needs** – Extending and redirecting the force main discharge to a larger sewer capable of receiving the pumped flow should be considered. The influent peak rate to the pump station is unknown and because upstream manholes overflow under extreme conditions, an accurate value may not be obtained. The City has televised the sewers tributary to the Vine Street Pump Station to identify sources of extraneous flow that can be removed. A new force main extended to a sewer with capacity to receive the discharge must be considered and sized to handle a future flow. The future flow may come from larger capacity pumps deemed necessary after the sewer and manhole rehab work has been completed. Construction of a totally new wetwell and pump station will be required and will depend, as does the size of the recommended force main, on the findings of the sewer televising work.
