# City of Iola, KS

## WASTEWATER COLLECTION SYSTEM REVIEW AND ASSESSMENT

DESIGN MEMORANDUM

PROJECT NO. 08A54-003-3704  
July 2011

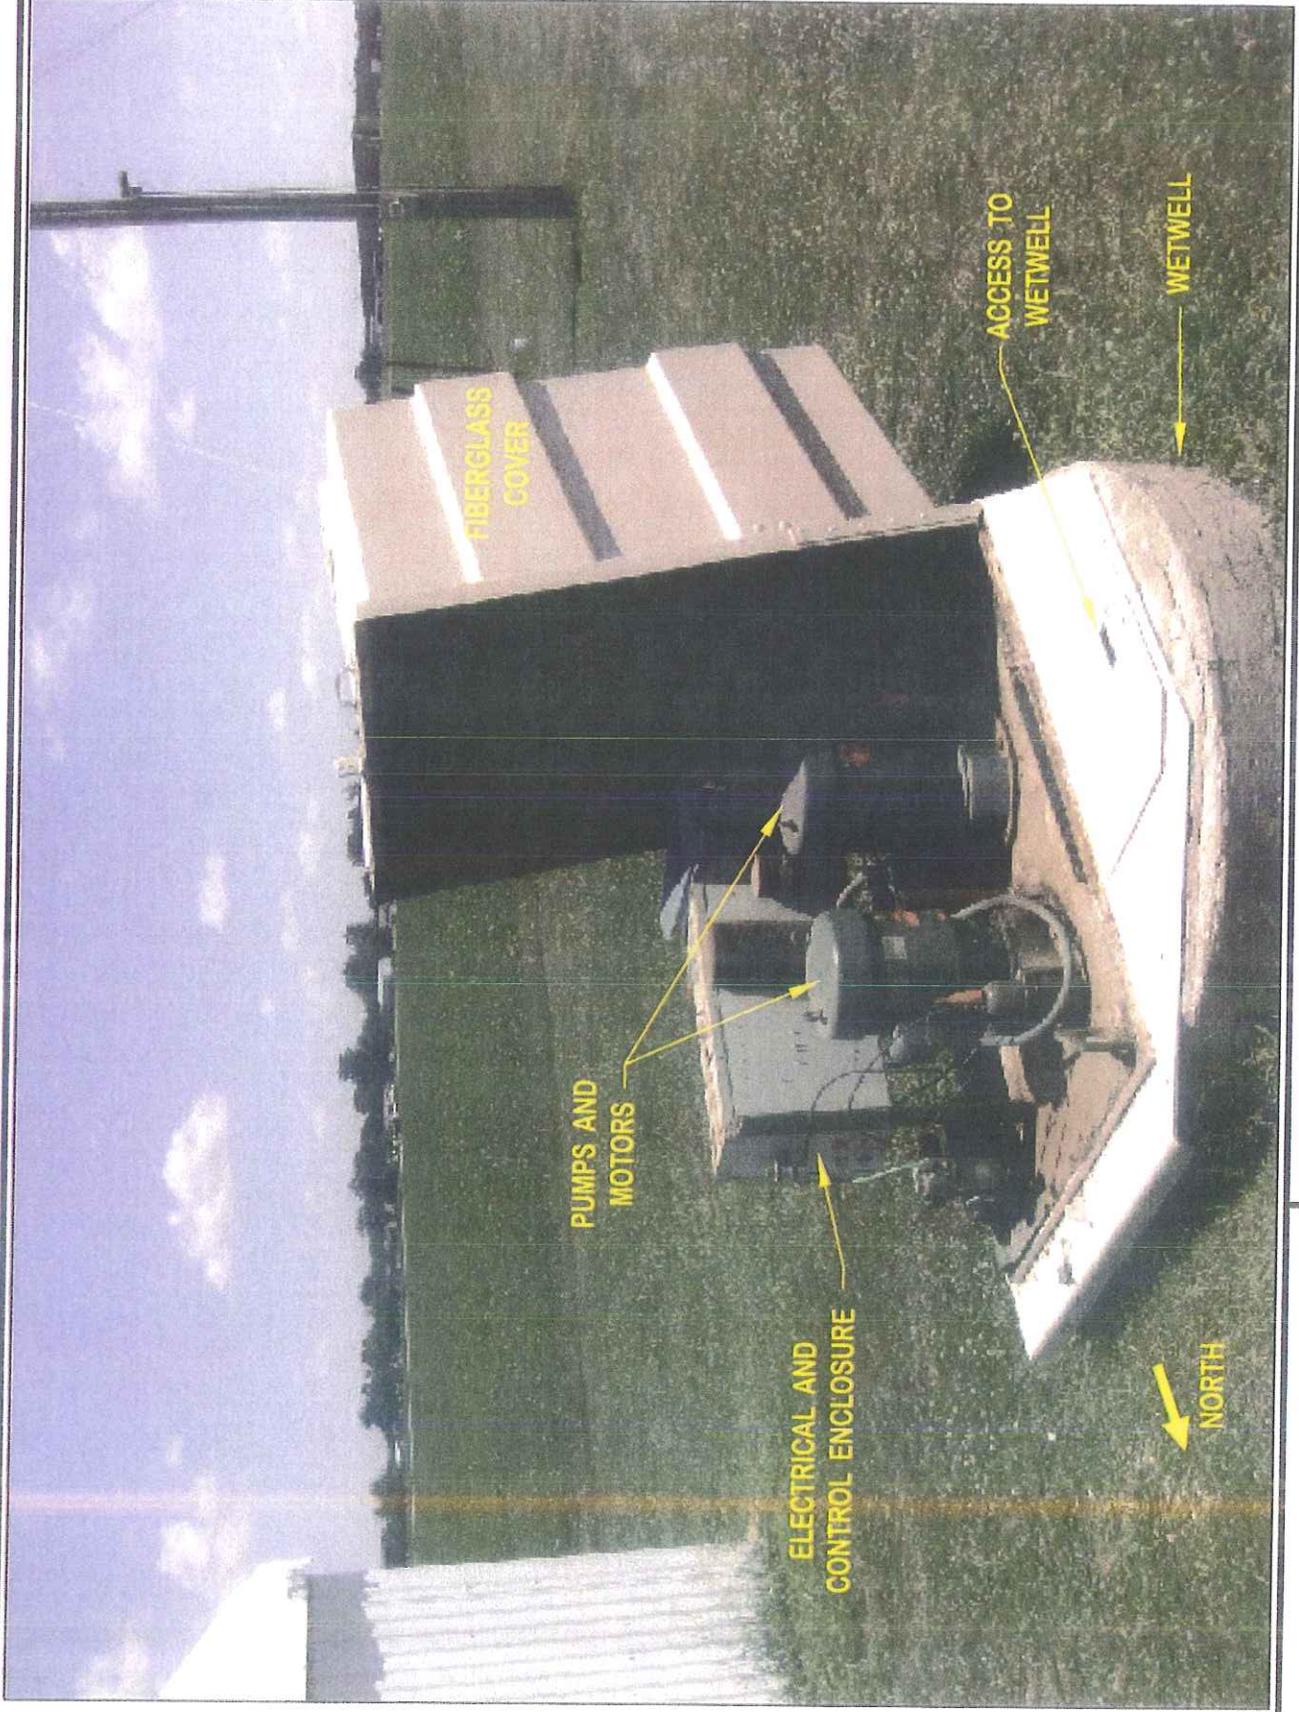
PHOTO 11  
MARSHMALLOW PUMP STATION  
COLLECTION SYSTEM ASSESSMENT

Marshmallow	vacuum primed, wetwell mounted, fiberglass enclosure over valves and control panel	< 200	200	float switches	2	2/2	4"/4"	6"/1,400'/PVC	240/3	1978	No	Smith+Loveless	n.a.	Pump station has little influent flow, it is in fair condition, and is considered reliable.
Water Plant	submersible pumps, separate valve vault, exposed control panel	< 100	100	pressure transducer	2	5/5	4"/4"	4"/2,500'/PVC	480/3	2005	No	Flygt	n.a.	Condition is good, no major work anticipated in the next 10 years
Cedarbrook South	submersible pumps, separate valve vault, exposed control panel	< 175	175	float switches	2	3/3	3"/3"	4"/470'/PVC	240/3	2009	No	ABS	n.a.	New in 2009. No major work anticipated in the next 10 years
Cedarbrook North	submersible pumps, separate valve vault, exposed control panel	< 100	100	float switches	2	2/2	3"/3"	4"/280'/PVC	240/3	2011	No	ABS	n.a.	New in 2011. Had not been constructed by publication date of this Design Memorandum.

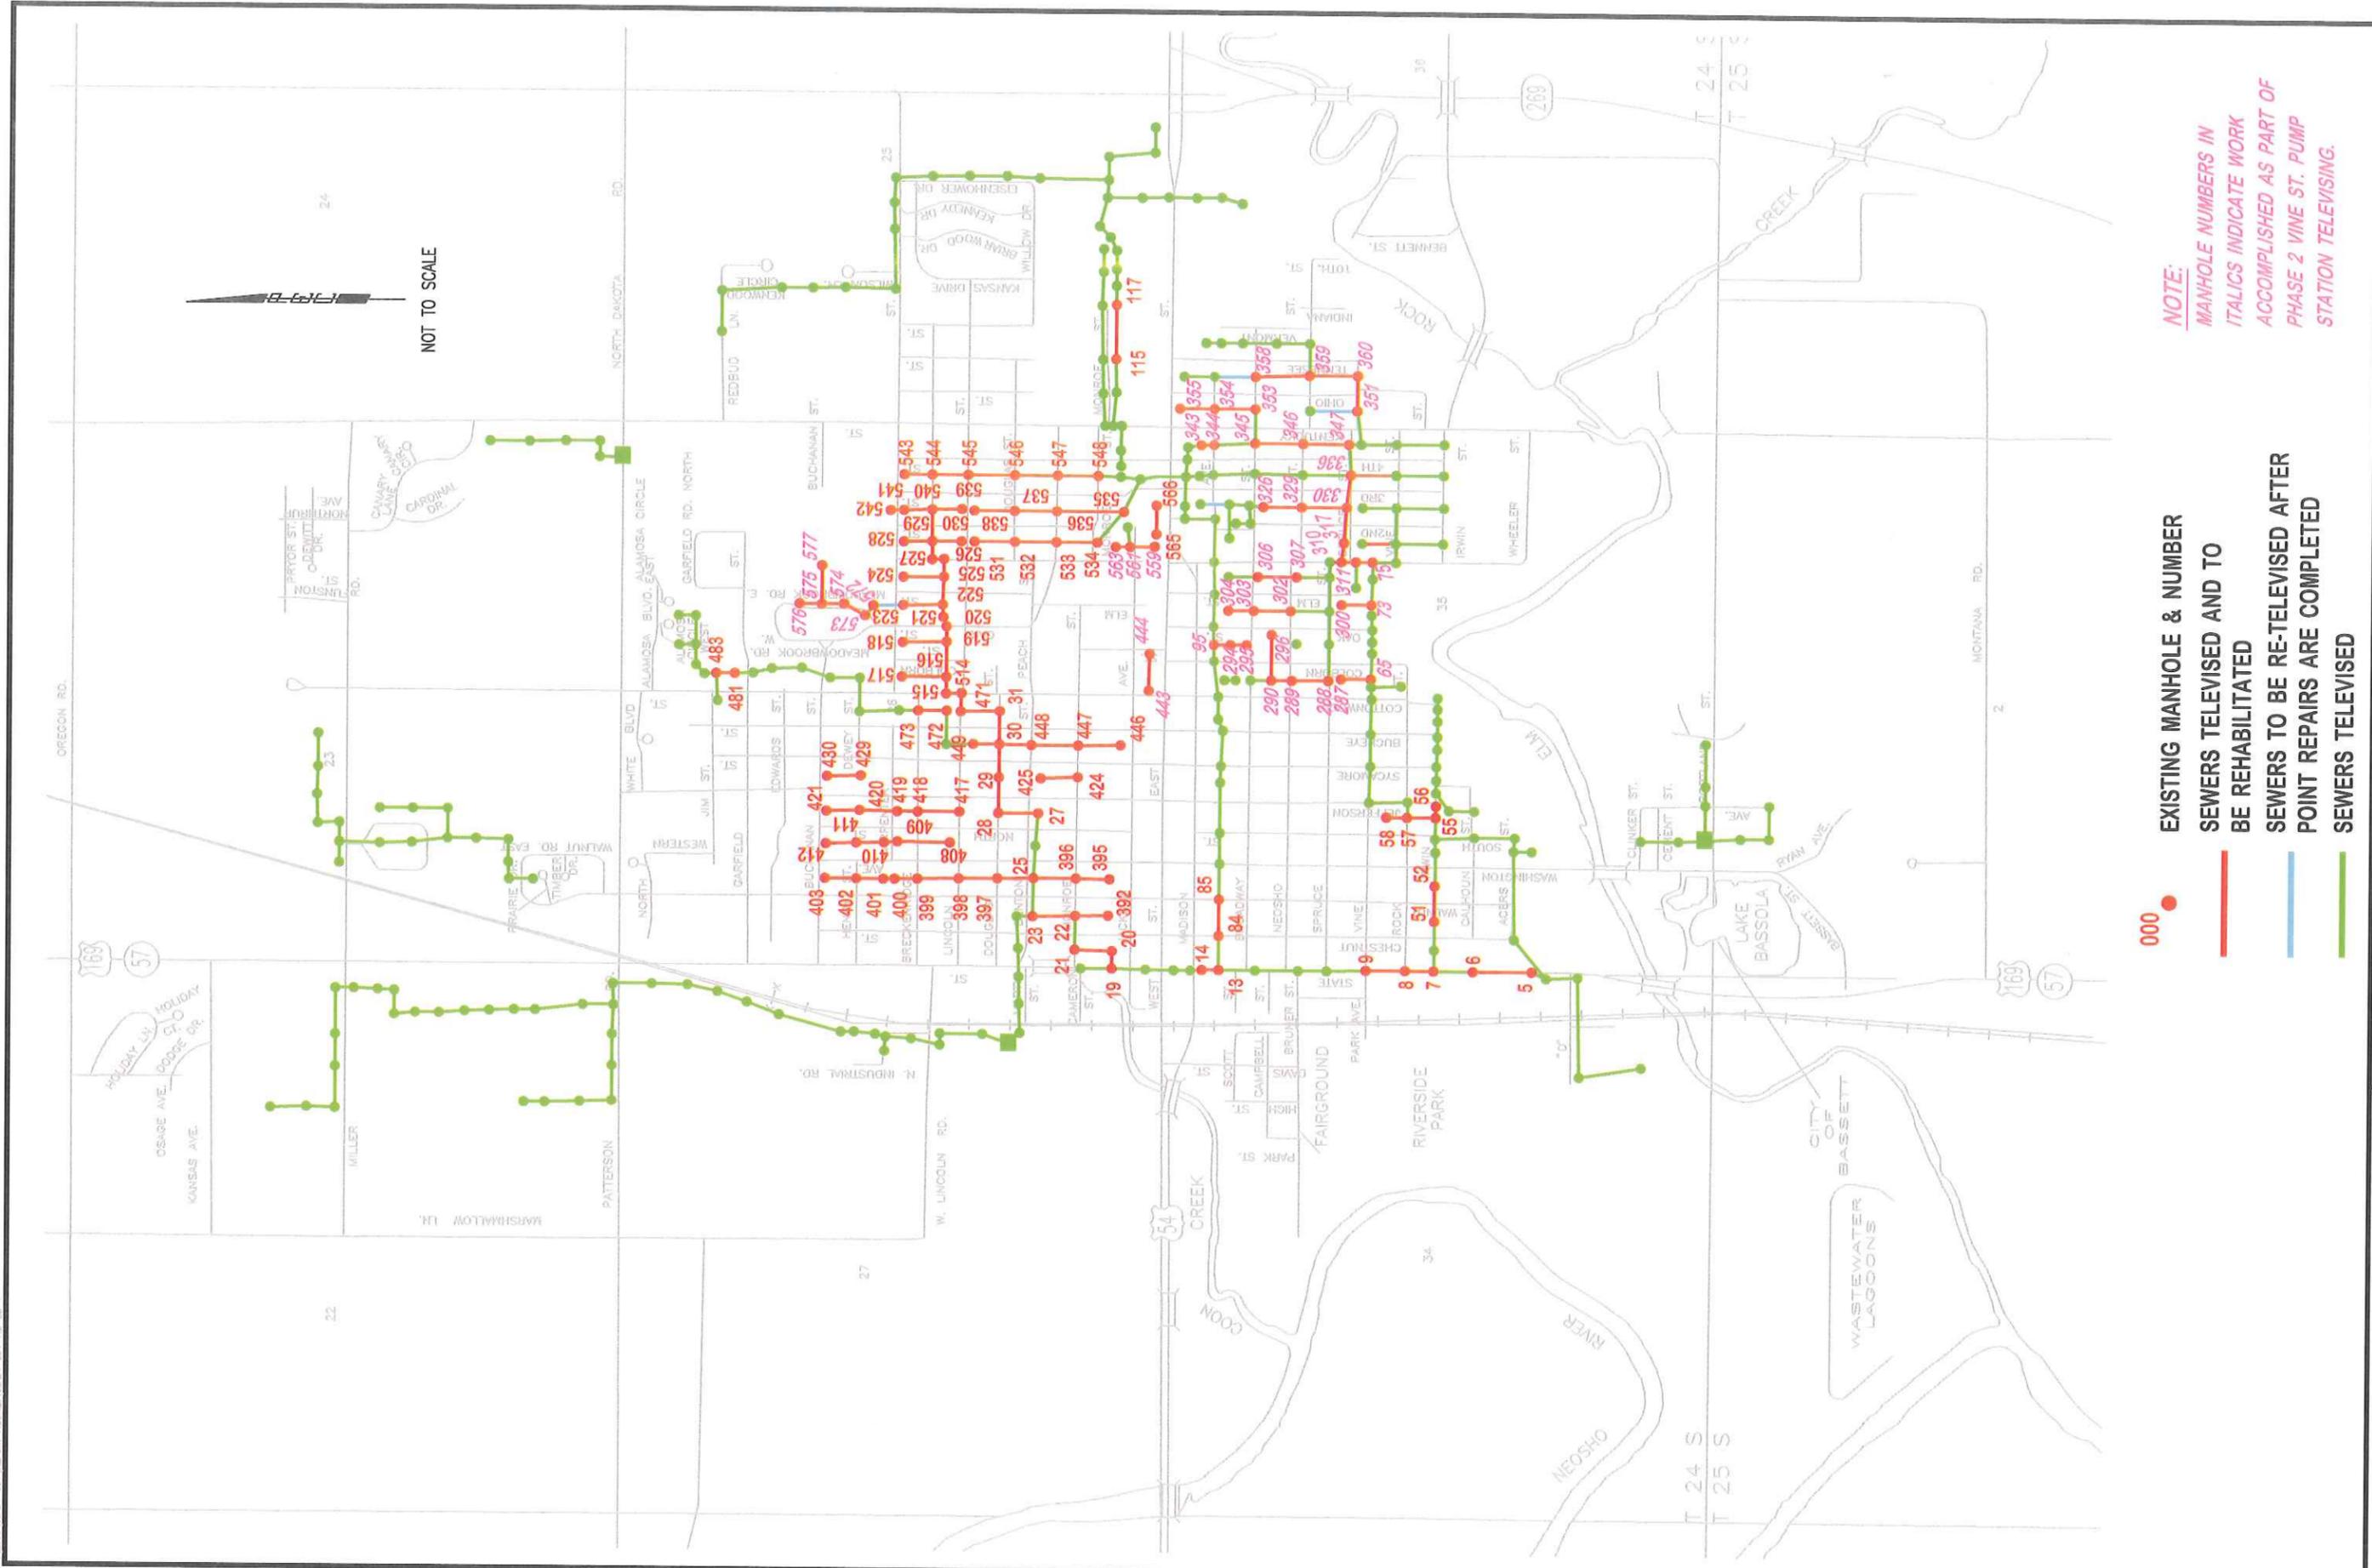
**FIGURE 5-1**  
**SEWER REHABILITATION**

Figure 5-1 shows the location of sewers that were televised. The sewers selected for rehabilitation are shown in red and those televised but not recommended at this time for rehabilitation are shown in green.

- A project to rehabilitate the sewers shown in Figure 5-1 Sewer Rehabilitation and listed in Tables 5-1a and 5-1b Sewer Rehabilitation.
- Manhole Rehabilitation listed in Table 6-1 Manhole Rehabilitation Table.

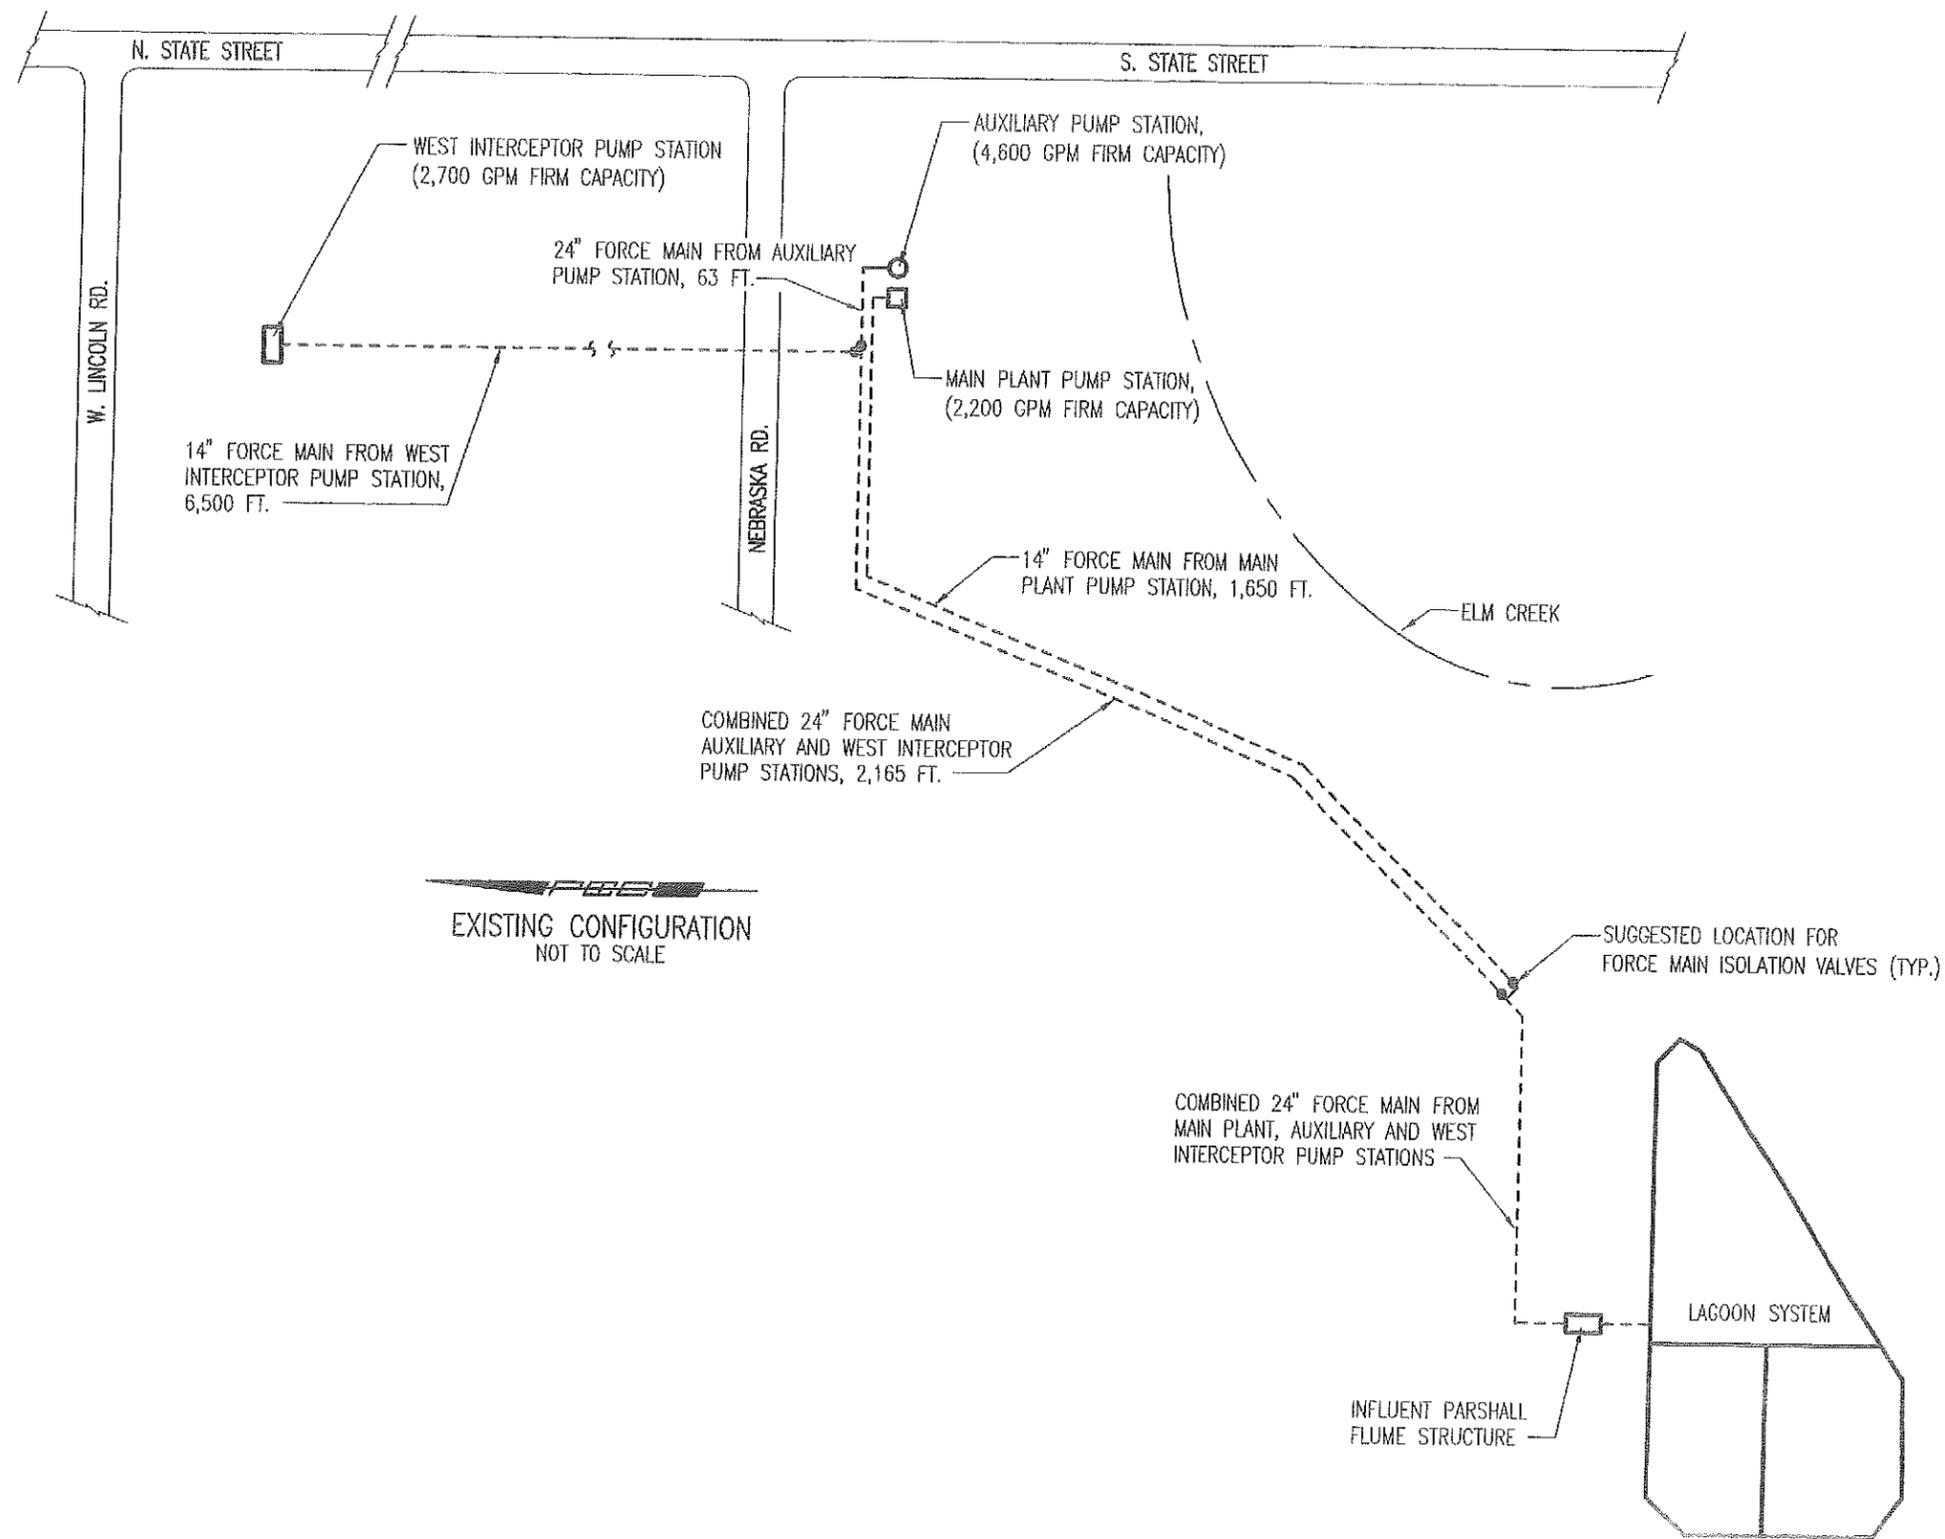
Figure 1 – Schematic of Pump Stations and Force Mains shows the interconnection of the force mains from the Main Plant PS, Auxiliary PS, and West Int PS. All three pump stations discharge to the Lagoon System through a shared 24" force main. Under normal operations and during dry weather conditions, the Main Plant PS and the West Int PS operate with only one pump at each station in service. During major rainfall events, the West Int PS requires two pumps to operating (firm capacity of 2,700 gpm), the Auxiliary PS is put into operation with one pump operating at 4,600 gpm, and the Main Plant PS is turned off. At these peak flow times, a total flow of 7,300 gpm (sum of the reported firm capacity of the Auxiliary and West Int PSs) can be conveyed through the force main system.

In the process of assessing possible modifications to the Main Plant and/or Auxiliary PSs, it became obvious that if there is any failure of any one of the three force mains, all three pump stations must be removed from service to allow a major repair. There are no valves in the force mains that would allow a maintenance crew to isolate a portion of a force main in a manner similar to what is done with water main repair. The recommendations at the end of this letter include installation of valves for the purpose of isolating portions of force mains so that at least some wastewater pumping can be accomplished during a force main repair. Suggested locations for isolation valves are shown in Figure 1 for the existing configuration. Locations for isolation valves are also indicated for each alternative, as appropriate, on the figure representing an alternative.

As shown in Figure 1 – Schematic of Pump Stations and Force Mains, there are no existing isolation valves on any of the force mains; consequently, making the connection between the 14" and 24" force mains shown in Figure 4 will require that all three pump stations be out of operation and the force mains sufficiently drained to accomplish the connection. A general contractor experienced in large diameter pressure piping in a buried situation should be utilized to complete this work. Replacement of the pumps and installation of the VFDs and controls can be considered as work City staff could undertake. The potential is addressed further under the paragraphs below titled: **Estimated Costs**.

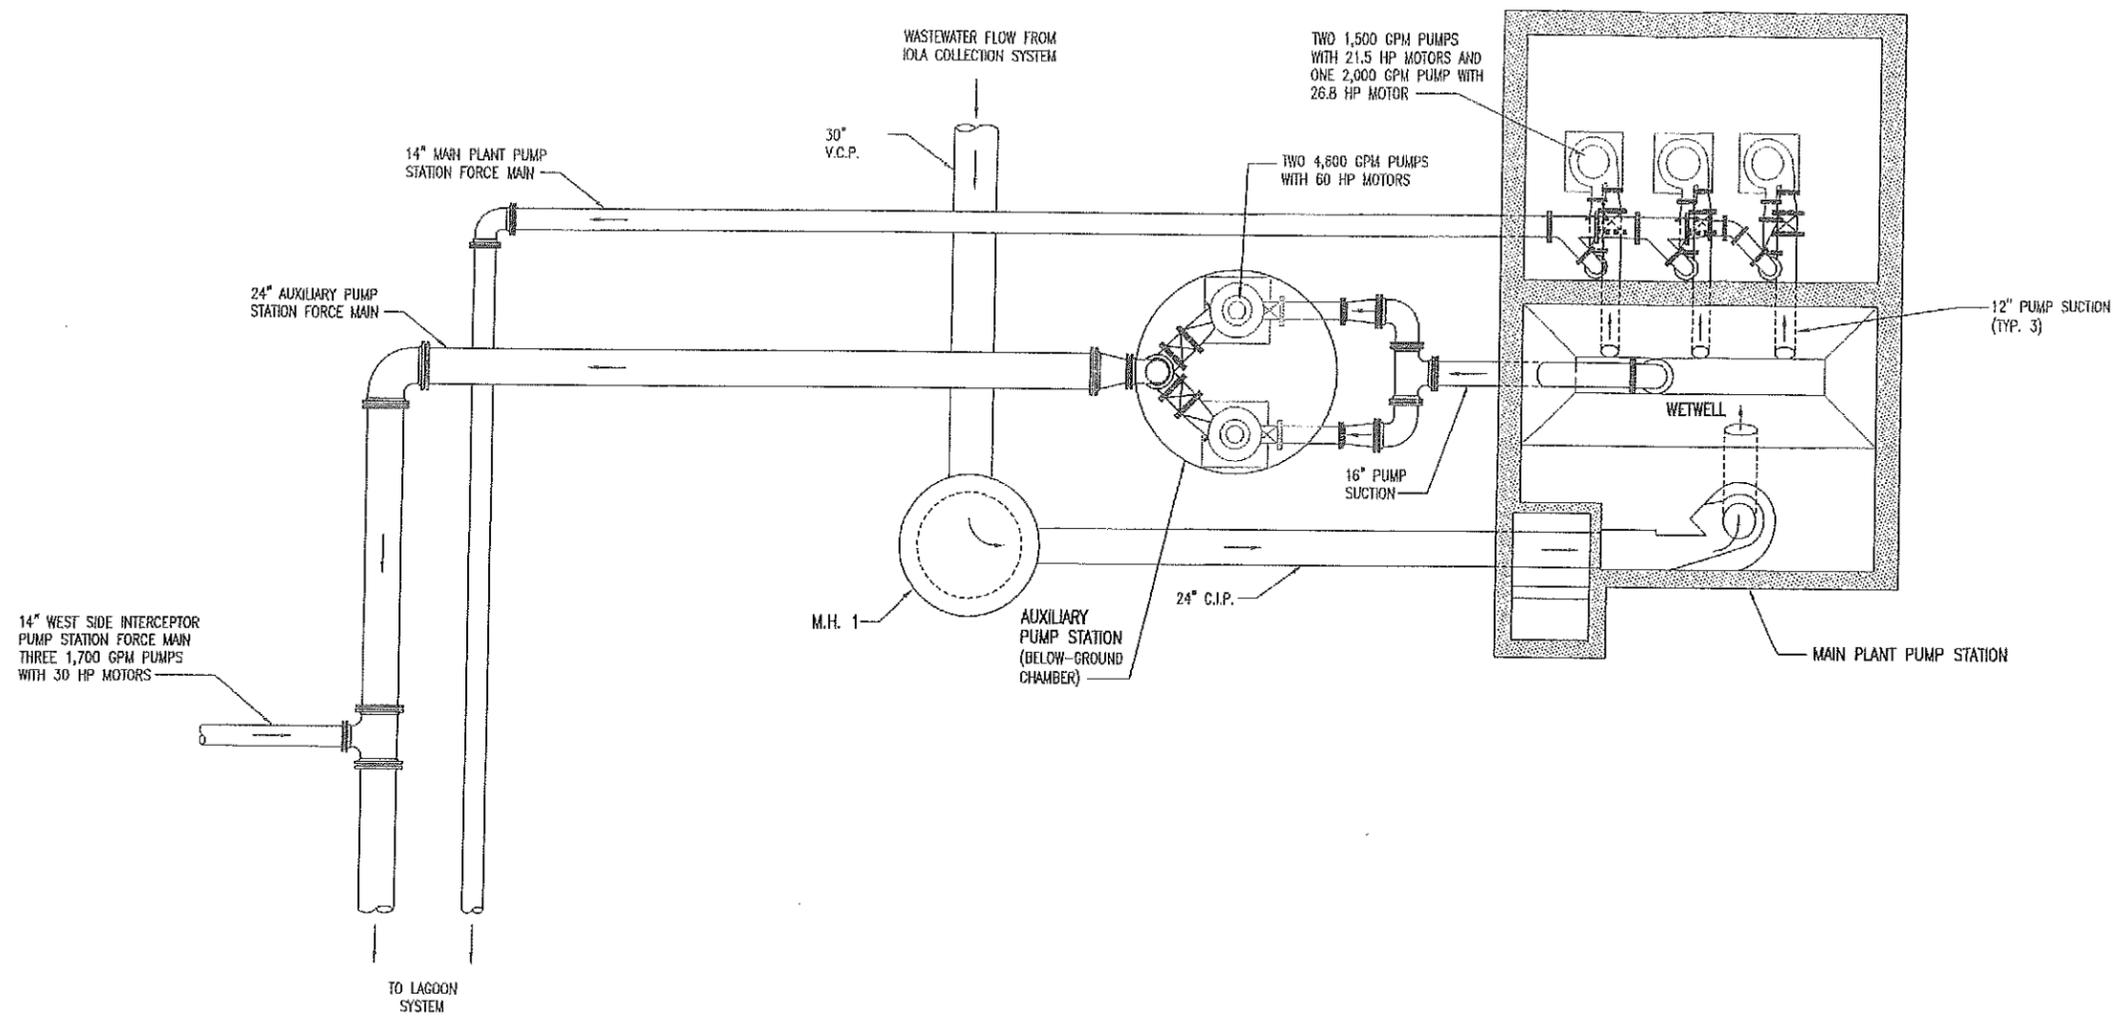
Figure 2 – Existing Main Plant Pumping Layout shows the general configuration in plan view of the Main Plant PS and Auxiliary PS. Wastewater flows by gravity from the east in the 30" diameter influent interceptor sewer to Manhole 1 and then south into the wetwell of the Main Plant PS. Under dry weather conditions and during moderate rainfall, up to two of the pumps in the Main Plant PS operate. The existing pumps are currently sized for pumping 1500 gpm from the two outer pumps and 2000 gpm from the pump in the center position. The firm capacity of the pump station is 2,200 gpm. During heavy rainfall events, when the pumps in the Main Plant PS are unable to keep up with the incoming flow, the Auxiliary PS, with a firm capacity of 4,600 gpm, has been placed into operation manually. The Main Plant PS is turned off by staff during this time. The Main Plant PS discharges to a 14" force main and the Auxiliary PS discharges to a 24" force main.
